Final Report on the SRB Frustrum "Smiley" Cracking Phenomenon Study

February 6, 1993

Thomas A. Cruse, Ph.D.
401 Bowling Ave. #6
Nashville, TN 37205
(615) 343-8727; (615) 343-8730 (fax)

SRB Frustrum "Smiley" Cracking Phenomenon Study

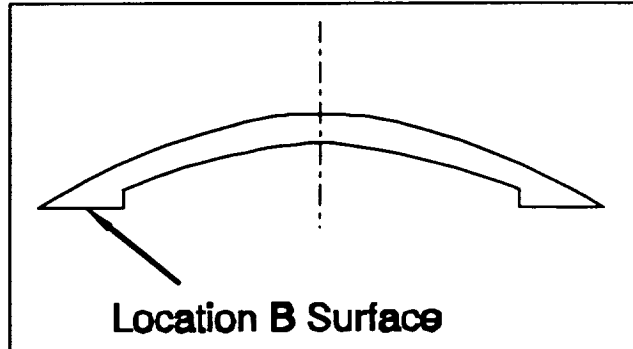
Figure 2 Cap Configuration Used for Sealant Application

very low strength of the bond at site B in the figure, corresponding to the MSA-2 bond on the overfill bead of the 1422 sealant. The very low strength conclusion is based on the lack of adhesion of the MSA-2 to the 1422 indicated by MSA-2 "fuzz" which is clearly seen on other locations of the debond. Examination of the witness surface on the MSA-2 material I removed showed a consistent picture - the MSA-2 surface at location B was quite smooth and had the appearance of a mold of the 1422 sealant.

Examination of the six debonded regions also shows that the adherence of MSA-2 to the supporting material is weak at locations A and C. In no case did the weak bond of MSA-2 to base metal extend more than a few mils from the edge of the 1422, but the metal surface clearly showed a lack of retained MSA-2 over a significant arc length of the failed zone. The radial extent of the weak bond is consistent with the size of the "voids" noted in the report on STS-48 that I read. The MSA-2 fractures were all featured as conical failure surfaces at roughly 45° to the substrate. The small radial extent of the weak bonded surface indicated to me that this location was not primary, but secondary in the sequence of MSA-2 fracture.

The weak bond of MSA-2 and 1422 sealant is radially large compared to that at location A. The weakness may include both locations B and C. The undercut showed very little likelihood of good bonding between the two materials. However, the size of the weak region associated with the overfill surface (location B) appears to be large enough to allow fracture associated with the depressurization event near the point of separation, when the external pressure at the hypalon is at its lowest point. Such depressurization fractures of the MSA-2 material were shown in the USBI M&P test report, without the need for external heating. In removing the MSA-2 material from the selected sites, I qualitatively noted that the bond to the crown of the 1422 sealant in cases where the debond did not include this region, was quite strong in comparison to that strength I noted in peeling the material from location B.

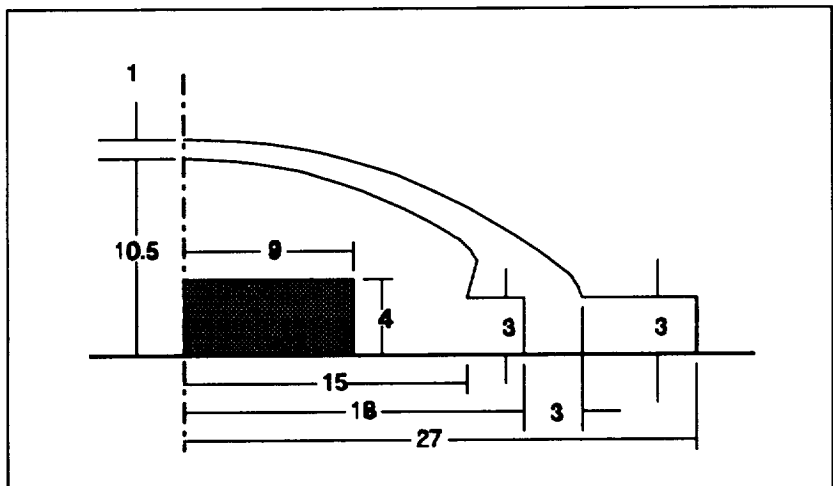
Figure 3: Nominal Dimensions of FEM Model (mm.)

The nominal geometry defined for analysis is shown in Figure 3, where the dimensions are given in millimeters. The configuration is taken to be axisymmetric, and only the right-hand side of the geometry is shown. The nominal geometry has been taken to have a large amount of excess PR-1422 material, taken to be 3 mm thick and extending to the edge of the low profile cap, which has been removed. The right hand edge of the indicated geometry is taken to be a surface with no normal motion of the MSA-2 material, thereby approximating the restraint of the surrounding MSA-2 material. The slight undercut of the low profile cap has been simplified by using an angle to the interface. The volume occupied by the fastener is indicated by the shaded region. The MSA-2 material is shown with a 1 mm thickness at the centerline, and a 3 mm thickness away from the fastener.

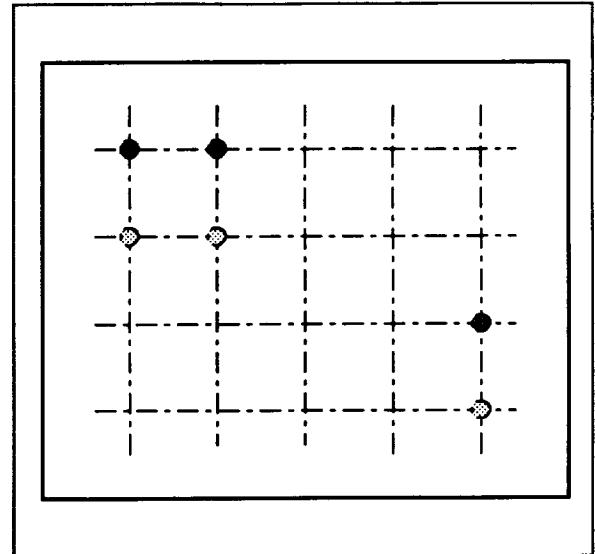
Figure 5: Proposed Test Panel

The test panels should be prepared in a fashion similar to that shown schematically in Figure 5. Each test panel of 0.125" thick aluminum contains four rows of five simulated fastener locations. The figure indicates typical locations for each of the 20 simulated fasteners, which are arranged in alternate rows of five with overfill, five without, etc. The simulated fastener locations were located on centers approximately 10x the size of the raised region which includes the PR-1422 material, and the raised MSA-2 material covering the sealant. The distance is to provide space sufficient to isolate each test location from all others, and for cutting each test specimen such that the 2"x 2" test specimen is large enough to minimize the influence of edge failures during tensile testing.

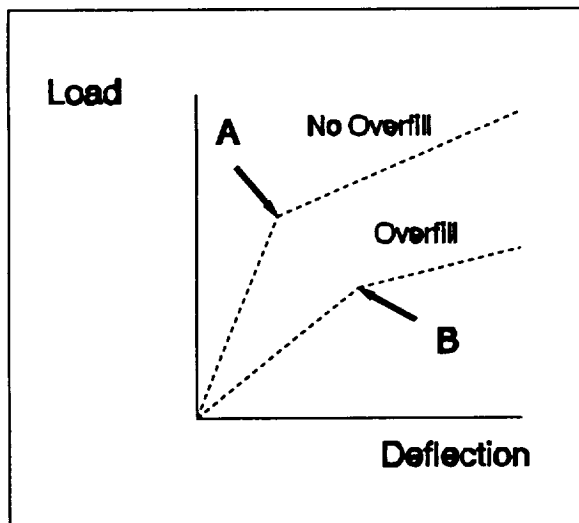
Figure 7: Schematic of the Load-Deflection History for the Pull Test

The pull test for no overfill of the PR-1422 material will show less compliance than for the test with overfill. The reason is that there is more MSA-2 material between the pull bar and the aluminum panel, to resist the applied loading. At a critical load level, the MSA-2/aluminum bond will fail (indicated in Figure 3 as point A). The loading will shift more toward the MSA-2/PR-1422 interface centered over the simulated fastener location. This load path is much more flexible than the original load path prior to bond failure and the load deflection curve will likely show a significant increase in compliance. Failure at the indicated failure site in Figure 6 will likely occur at point A in the load history.
